United States
Coast Guard

Subj: INVESTIGATION INTO THE CIRCUMSTANCES SURROUNDING THE GROUNDING OF
THE MOTOR VESSEL NEW CARISSA, LLOYD'S NUMBER L8716136, OFF COOS BAY,
OREGON, ON 04 FEBRUARY 1999, WITH MAJOR POLLUTION AND NO PERSONNEL
INJURIES OR LOSS OF LIFE

NEW CARISSA One-Man Formal Investigation

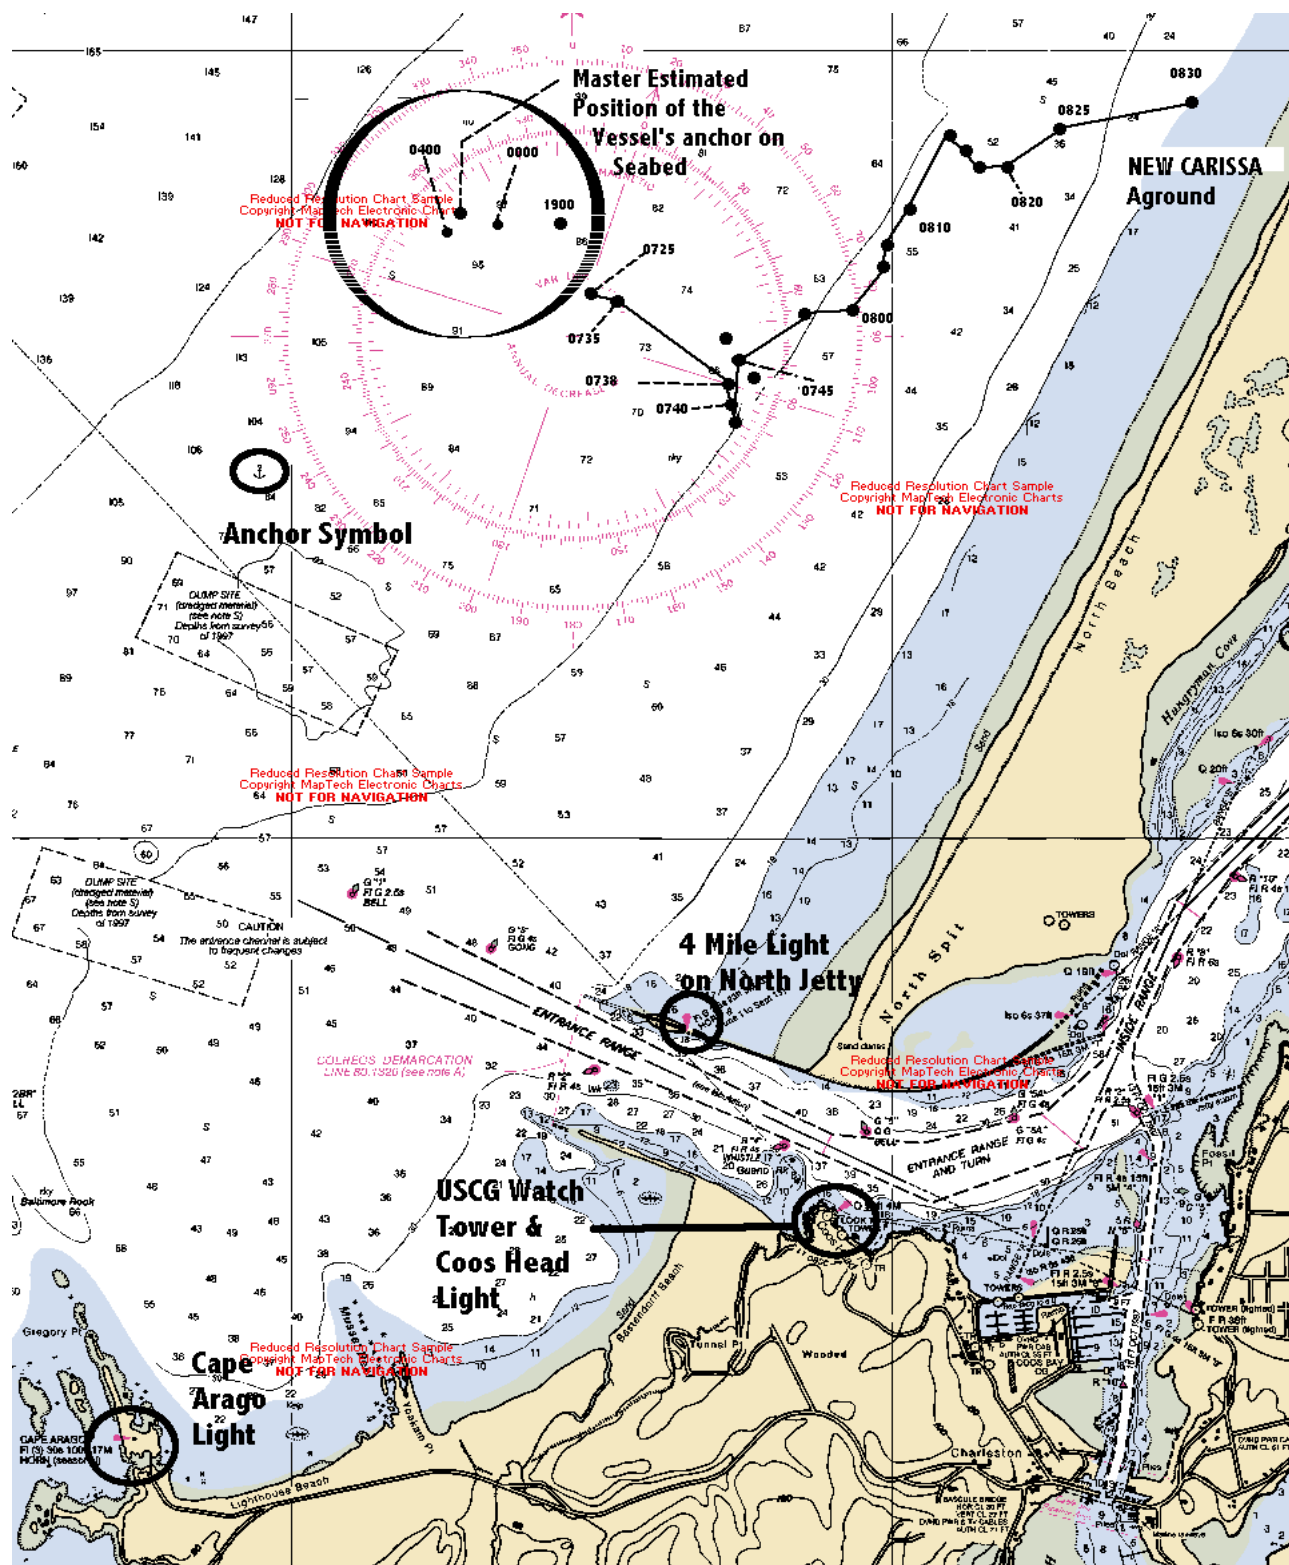
The above graphic is a representation made by the Investigating Officer for the purpose of capturing the information found on the chart used by the NEW CARISSA's deck officers. This graphic is provided to assist the reader in seeing the charted position of the NEW CARISSA from anchor to grounding. Terrestrial reference points useful for area familiarization are circled for easy reference.

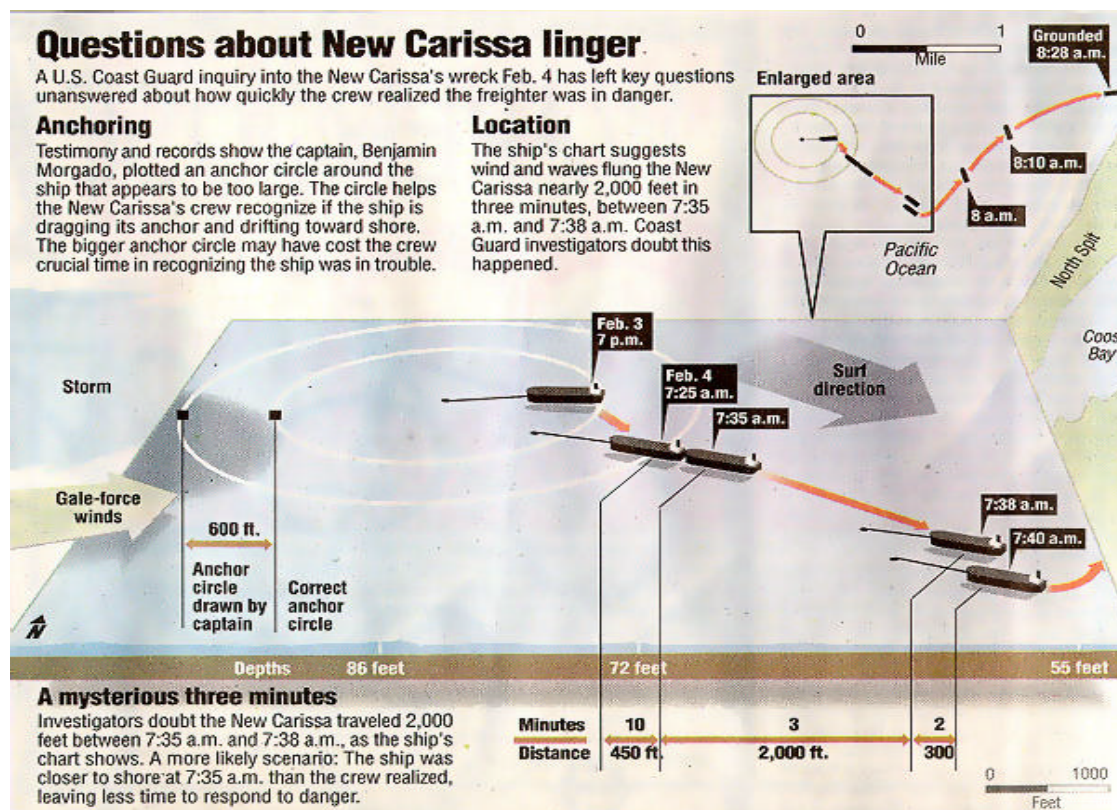
- m. The 0725, 0735 and 0738 positions on the chart which were used to justify that the vessel was dragging uncontrollably are unreliable.

The graph representation below best illustrates an overriding question which the hearing was unable to resolve, that being an explanation of how the NEW CARISSA could travel at a speed of 7 knots with its anchor on the bottom and engines going ahead. Specifically, the ship's officers could not explain how the vessel traveled 700 yards (0.35 NM) during the three minute period between 0735 and 0738.

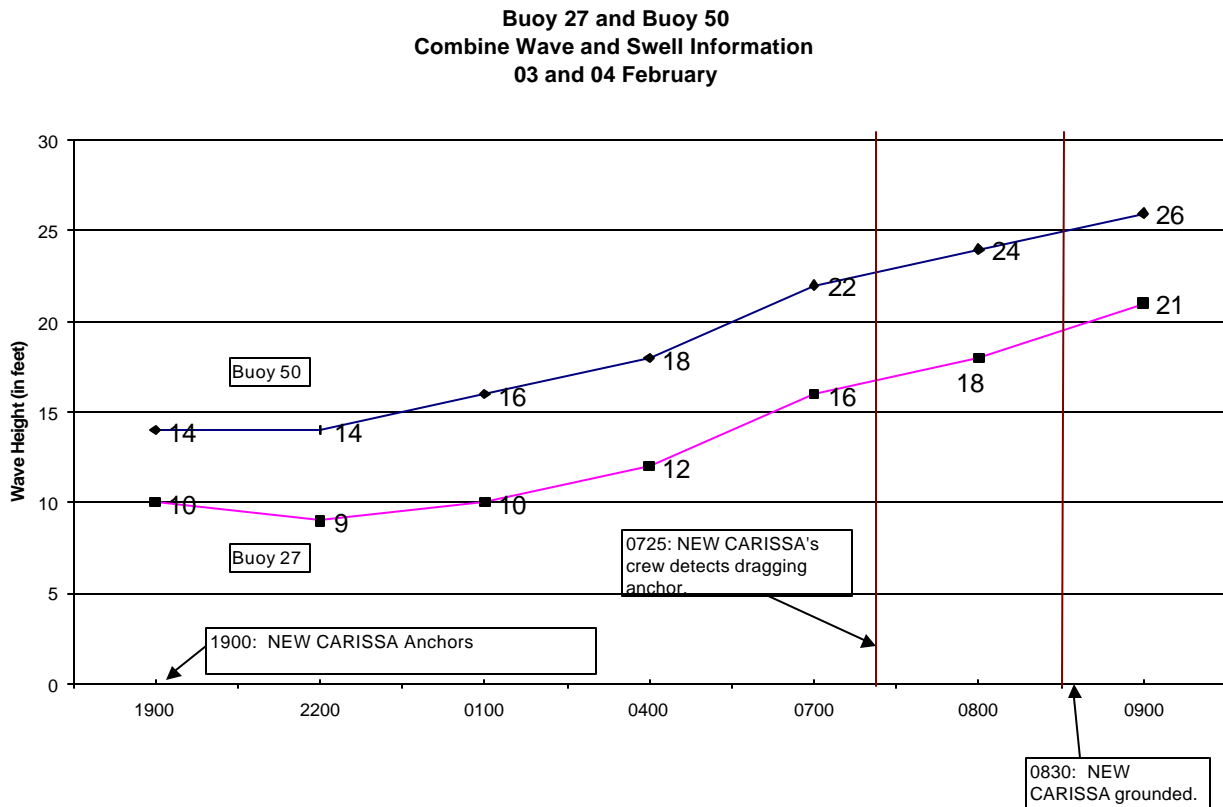
Sea state is best determined by extrapolating the available data recorded by the offshore weather buoys. The two closest buoys reporting seas are buoy 50 offshore of Newport, Oregon and buoy 27 offshore of St. Georges, California. These buoys are approximately 100 miles north and south of Coos Bay, respectively. There is no means for determining wave height from the Cape Arago, Oregon station.

On 4 February 1999, buoy 50 measured seas of 24 feet⁵ at 0800 PST. One hour later the seas were recorded as 26 feet. South of the area, at buoy 27, seas were recorded as 18.3 feet at 0800 PST, and 21 feet at 0900 PST. The seas in the Coos Bay area were somewhere between these readings, most probably, in the 20 foot range around the time the ship detected its anchor dragging (0730 PST). The swells continued to increase until about 0900 PST. The direction of the swells was from the west-northwest on 4 February as testified to by the Coast Guard Watch Stander in the Coos Bay tower.

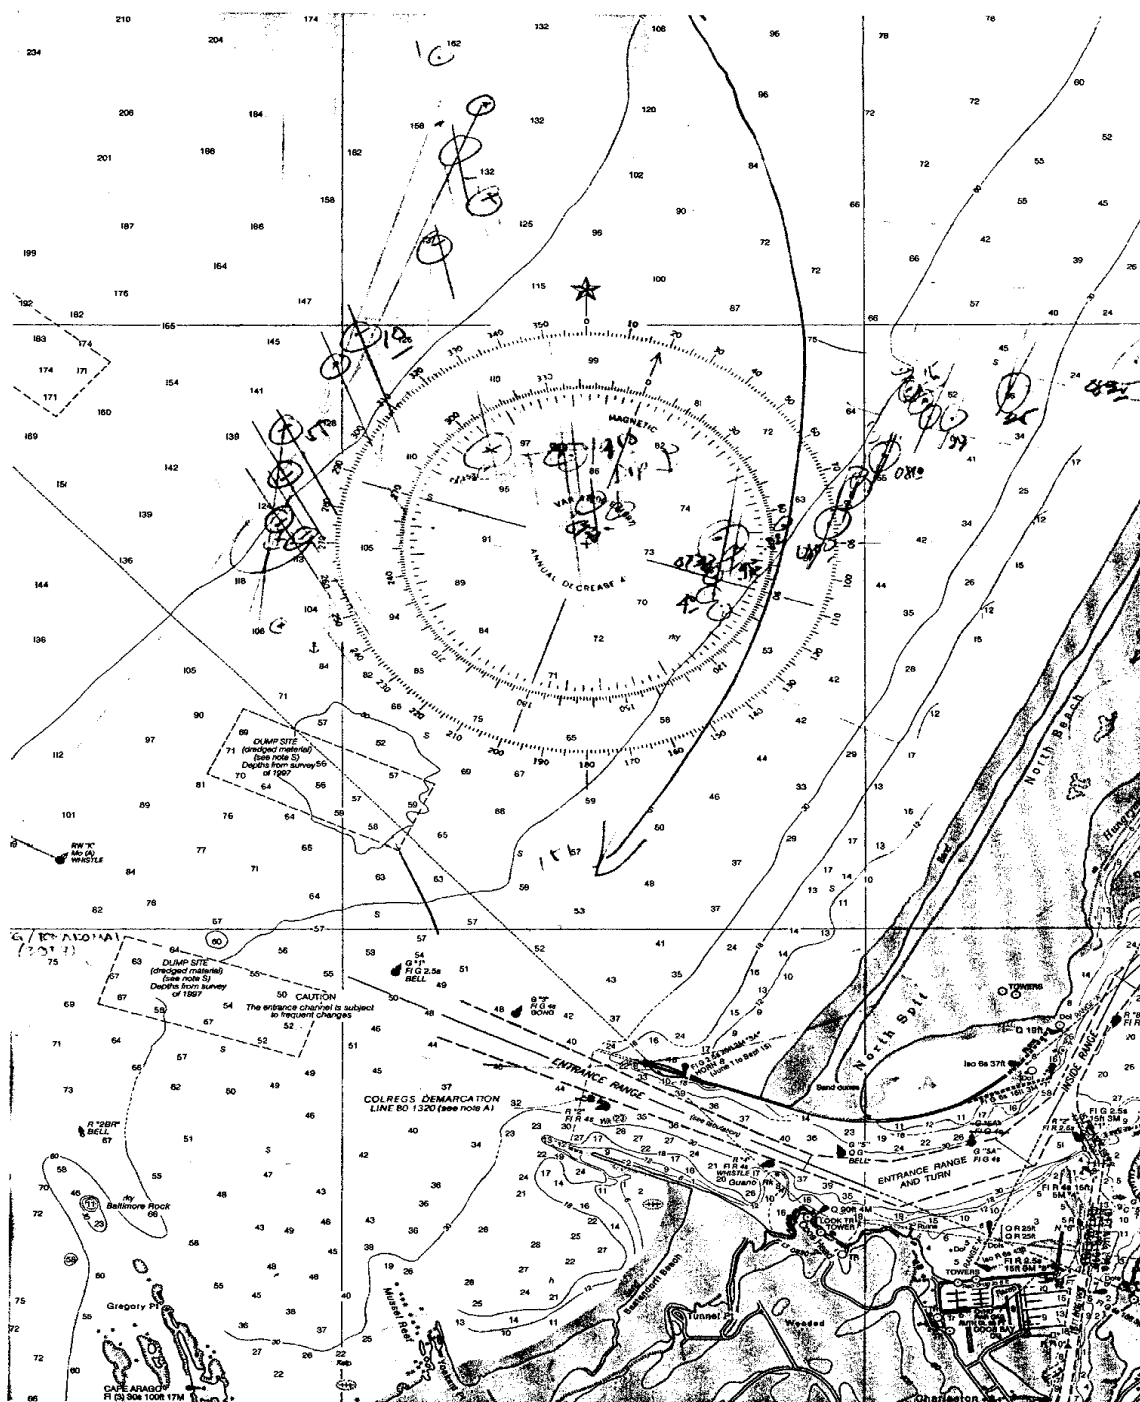
APPENDIX 2: Reproduction of Chart 18587 taken off the NEW CARISSA

Upon review of the drag circle placed on the NEW CARISSA's chart, it was determined that its radius was 200 yards too large.

The Chief Officer immediately looked into the radar and found that the vessel was 1.8 NM from the breakwater and approximately 30 yards outside of the anchor drag circle that the Master had placed on the chart the previous evening. This would place the ship 240 yards outside the correct drag circle due the aforementioned error in drawing it.

The above graphic is a scanned image of the chart entered into evidence at the hearing representing the NEW CARISSA's charted position from anchoring until grounding.
